# SUNDOWN M RANCH YAKIMA, WASHINGTON

Dr. R. Gordon Bloomquist, Ph.D.,  
Washington State University Energy Program

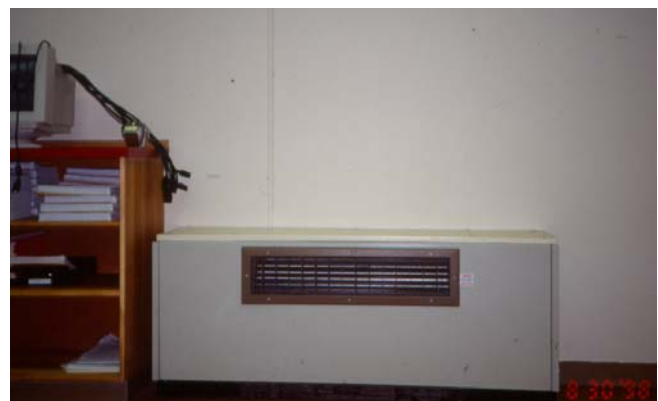
*Figure 2. Console heat pump.*

The various facilities are served by a combination of heat pumps and heat pump unit ventilators (Figure 2). Water is circulated in an open loop to each building. Circulating pumps serve to boost the flow through the various buildings. A total of 297 heat pumps supply the complex comprised of 257 1-ton (3.5 kW) heat pump unit ventilators, 12 3-ton (10.5 kW) units, and 28 5-ton (17.6 kW) units for a total of 433 tons (1,523 kW). In addition, there are four 5-ton (17.6 kW) water-to-water heat pumps in the adult building for hot water and two 5-ton (17.6 kW) units with back-up electric water heaters serving the youth facility (Figure 3). There is a 1,000 gallon (3785 L) hot water storage tank in the adult facility.

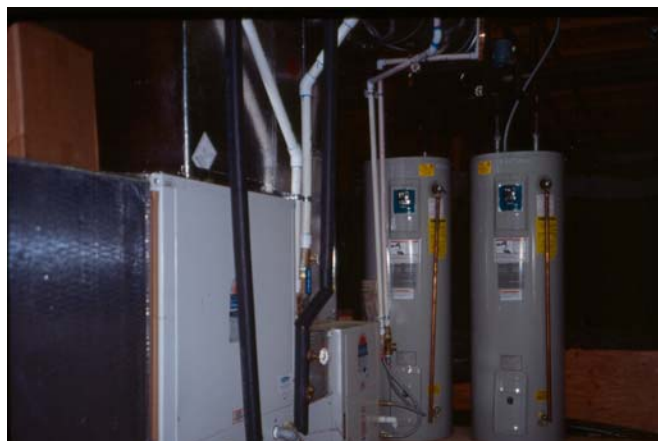
*Figure 3. Water to water heat pump.*
